NATIONAL TRANSPORTATION SAFETY BOARD

MATERIALS LABORATORY FACTUAL REPORT

Report No. 15-047

Date : August 1, 2014 Vehicle : Cessna 150M NTSB No. : ERA14FA387

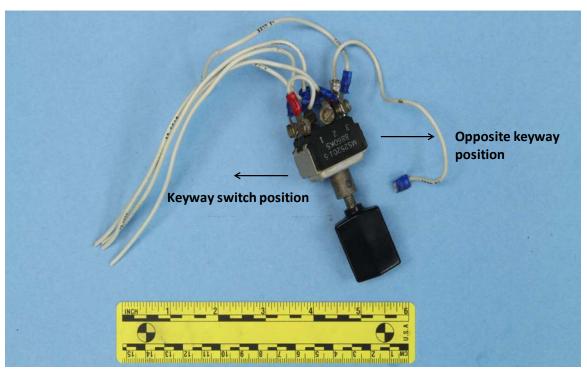
When the switch was submitted to the laboratory, the switch would toggle in both directions ("keyway" or up(towards connectors 1-4) or "opposite keyway" or down (towards connectors 3-6); however the "return to neutral" function was inoperable. The switch was radiographed in each switch position to determine if the contact heads were operating as designed and to determine why the neutral position function was not working. All contact positions appeared to be working as normal. This was confirmed through continuity testing which is discussed below.

Figure 1. Cockpit flap switch with switch in neutral position.

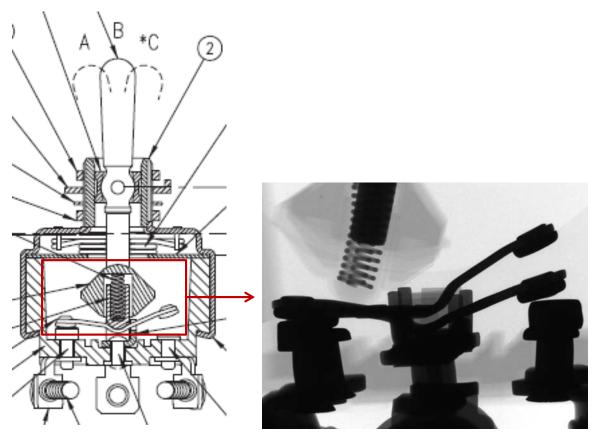
The return to neutral function operation is due to a spring located in the main body of the switch. A radiograph of the main body of the switch showed a fracture in this spring. The drawing with the corresponding radiograph of the same area is shown in Figure 2.

Figure 2. Drawing of switch body with radiograph of corresponding area (highlighted).
